Ye Olde Wine Shoppe No 10 Swansea

Shop Lantern

Conservation Report

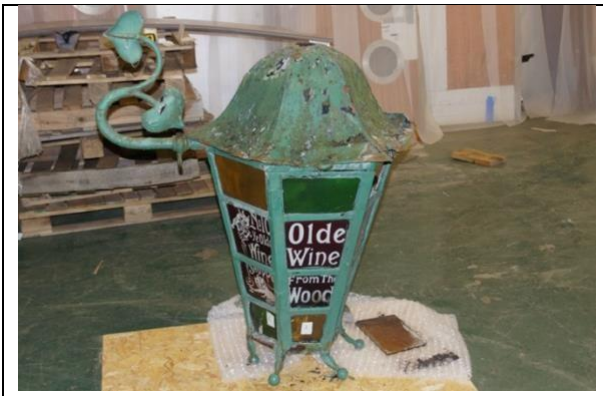
<p>The original lantern removed from the building to a workshop for initial assessment.</p>	<p>A detail of the fixings holding the lantern to the wall of the building in Union Street, Swansea.</p>

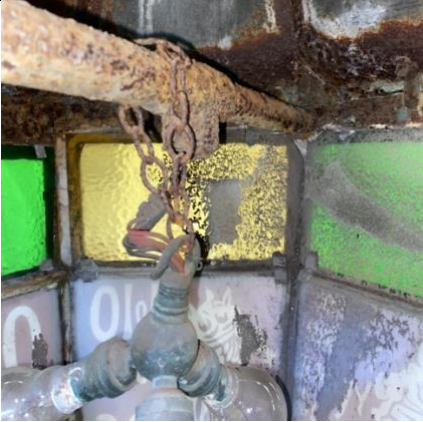
The iron tube running through the lantern with an electrical fitting suspended by an iron chain.	The iron flat to the top of the lantern frame with a hole cut for the end of the iron tube.

It was only possible to view the inside of the lantern through the two openings in the frame where the glass panes were missing. The glazing bar surfaces appeared rusty as if they had no paint coatings applied. There was also a layer of dirt to the surface of most of the glass panes. The iron support tube had a build-up of rust layers to its surface. The same was true of the iron chain supporting the brass light fitting.

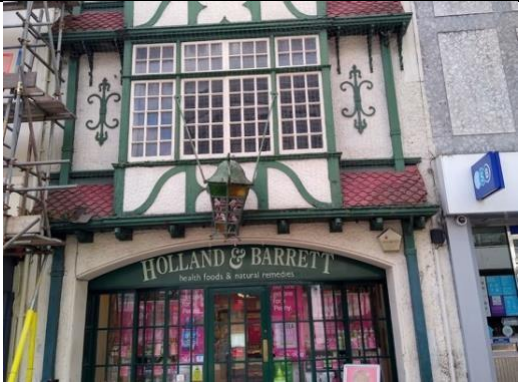
The lantern was found to be in a generally poor condition. At some point in the past it appears to have suffered a physical impact resulting in damage to the front foot and the pushing back of the bottom of the lantern from its upright hanging position. Inspection of the lantern showed that this had caused the iron support tube to move out of position, passing through the top corner of one of the window openings. The lantern was left leaning forward and twisted slightly to one side.

The front of the Holland & Barrett building showing the lantern no longer hanging straight.	Failing paint coatings visible to one of the heart decorative elements.

- Straighten and repair the cracks to the top rail
 - Re-attach the rear frame upright to the top rail making sure it sits inside the frame section
 - Straighten the bent front foot section by carefully heating and manipulating by hand back to its original position

- Straighten the slightly twisted leg to the left side of the lantern
- Clean the lantern tie rods and fixing bolts back to a sound metal surface by careful abrasive blast cleaning.

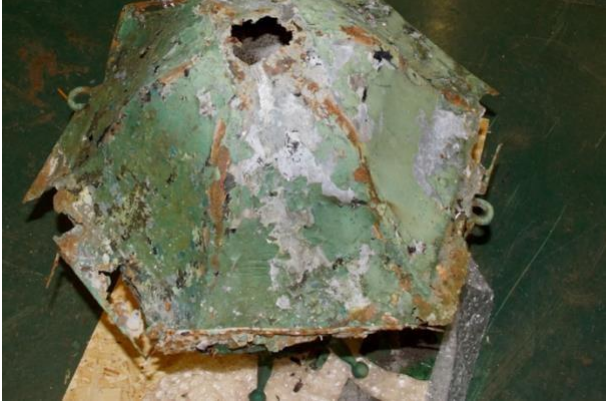
The lantern top covering (tent) was in the poorest condition. Much of the paint remaining on the outer surface was peeling and flaking. This thin iron sheet material had corroded to excess along its outer edges where it over sailed the top edges of the lantern frame. The iron reinforcing wire, around which the edge of the top covering was folded, had also corroded and broken in a number of places. This covering had been left with a number of holes to the metal sheet. Viewed inside, it appeared that the top covering had an internal lining (or the remains of an earlier top?) that had a galvanised finish. This zinc coating had been lost around the edges of each inner section exposing the iron surface to corrosion beneath. As a result, a layer of rust had formed, particularly along the corner folds. The top centre part of the covering was missing with a ragged hole present. Originally, there would have been a chimney to vent the lantern when gas or decorative finial present (a historic photograph appears to show a pair of spheres, one on top of the other).

<p>The edges of the top covering showing the corrosion and metal losses present. Note also the physical damage around the edges.</p>	<p>A view inside of the roof covering showing the remaining zinc coating and the rust layers present where it has been lost.</p>

- Repair the top covering piece:
 - Make a cardboard template of the bottom edge of the covering to one section to ensure the original shape is retained when repaired

- Remove the remaining sections of core wire and assess to see if they can be re-used
 - Cut back the corroded edges of the top covering to a sound edge

- Make up new edge repair pieces in steel sheet rolling the bottom edge over to allow the core wire to be re-fitted, and attach to the sound edges by careful brazing or soldering

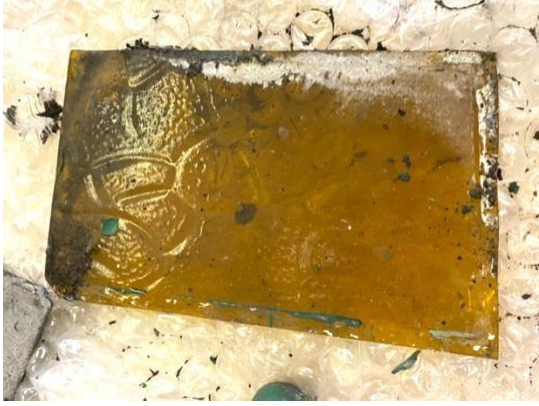
All the original glass panes were found to still be present but two had become detached and fallen (or placed) inside the lantern. One was complete apart from a small corner section missing (orange pane). The other green pane was broken in half. All the remaining glass pieces were well fixed to the lantern frame. The glass pieces were found to be dirty, particularly to their inside faces. A number were cracked, and this is detailed in the attached drawing in Appendix I below.

<p>The detached textured orange glass pane showing dirt present and the missing corner.</p>	<p>A view of the glass panes inside the lantern showing the dirt layers present.</p>

- Glass panes are to be cleaned using deionised water with a little added non-ionic detergent (TritonX100) to remove dirt accumulations, before careful drying with paper towels.
- Broken glass panes are to be repaired using a water white, conservation grade adhesive. Sylmasta Hxtal Epoxy Resin adhesive is recommended.

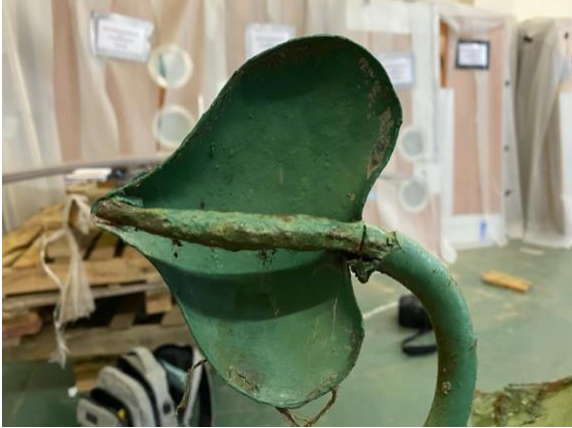
The large decorative, tubular scroll section to the top of the lantern front was in a fair condition. The paint layers had begun to fail. The lower repoussé decorative heart detail had one side missing. This appeared to be an old loss as the inner face of the remaining half had been painted.

<p>One of the two repoussé hearts showing the missing side.</p>	<p>The ends of the tie rods with the fixing plate at one end and the hook that fixed to the lantern, at the other.</p>

- Remove the remaining rust layers to the inside top cover section retaining the surviving galvanised layer
- Repair the damaged heart detail to the large front scroll by making a new heart piece from copper, using the original as a template. Solder the two halves together and fit back onto the scroll section.

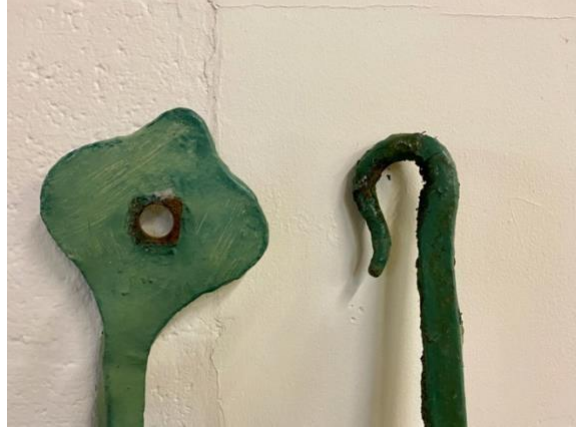
The two tie rods were complete and still straight despite the earlier damage to the lantern. The original paint layers present were failing and coming away from the metal surface.
